Rowe BC8 - BC35 Bill Changers
BA-3 to BA35 acceptors

An overview by Bruno D Puglia
East Coast Amusements
Canton, MA.

April 13,2005

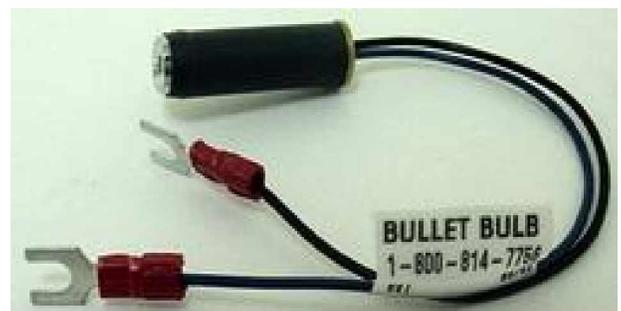
Some of the new update kits include a 755 Bulb replacement. A red LED is used. I like that Bullet LED replacement. Watch the color code. You can purchase the bullet LED as a separate item.

Some of the new update kits include a 755 Bulb replacement. A red LED is used. I like that Bullet LED replacement. Watch the color code.

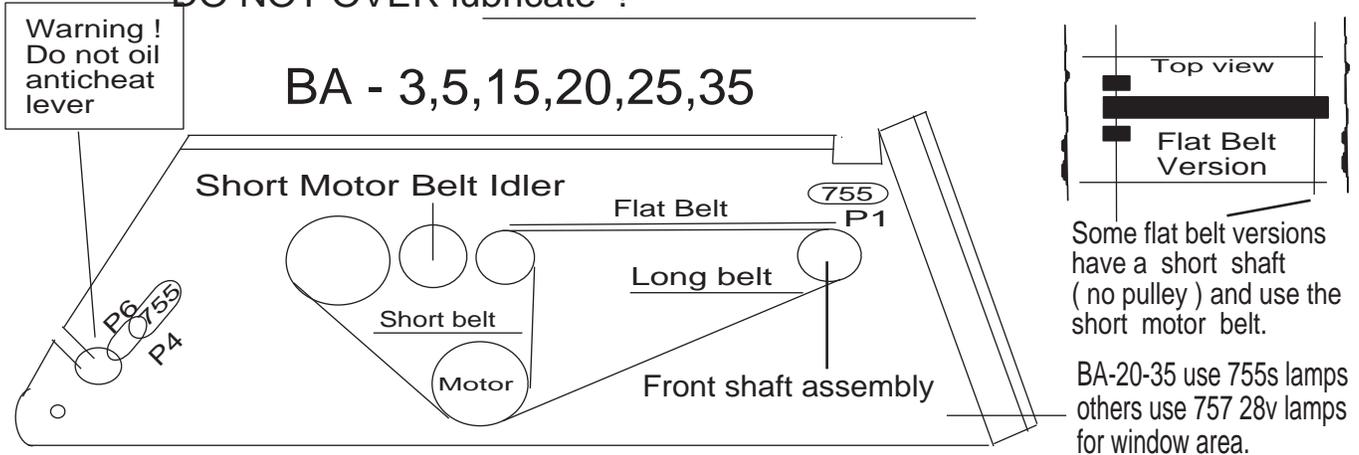
BA 3-35 Acceptor lubrication and cleaning

Needle point lubricate every \$30,000 or at least twice a year.
DO NOT OVER lubricate !

Clean the photo cells and plastic lenses with Kodax lens cleaner. Clean the center flat belt (flat belt version) and rubber rollers with rubber drive cleaner or denatured alcohol, and the mag head pressure roller with scotch tape as needed. Needle point lubricate ALL the small nylon bearings and the motor belt idler shaft and roller. DO NOT get oil near or in the anticheat (flipper) lever. Use only # 755 bulbs on top plate assembly.

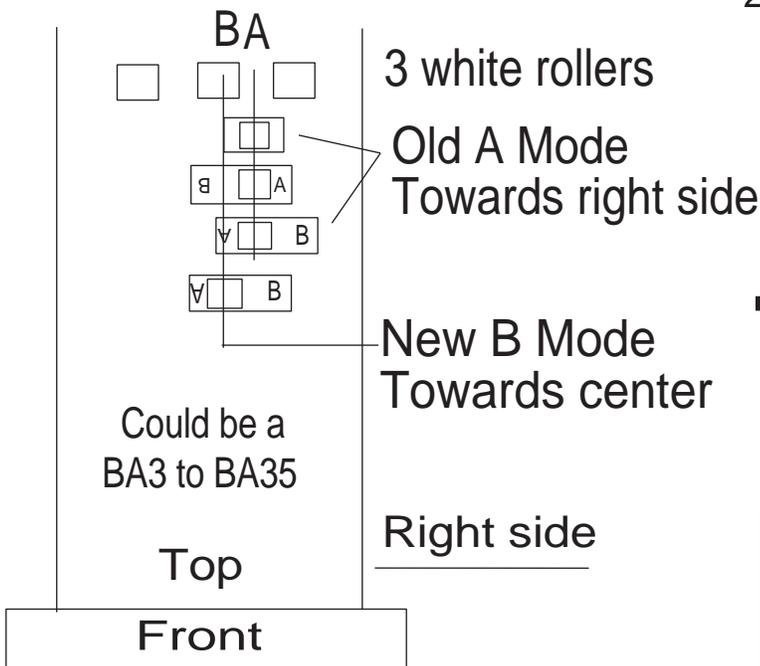
BA acceptor A or B Head position

Older BA acceptors have a Mag head position called "A" mode. A newer acceptor may be A or B mode. In the older A mode the Mag head is closer to the right side. The B mode is moved towards the center. The B mode is only used with a -20 board with the head switch in the "B" mode position. **The pressure roller must be directly under the mag head in either A or B modes.**

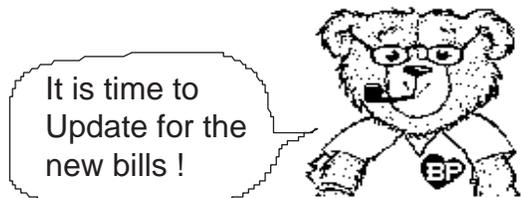
New Mag Head B Position

The new B position did help get higher security but over the years the \$1, and \$5 bills have changed enough so the B option became critical to accept today's bills. I have already converted several B option acceptors back to the A option by turning the mag head, pressure roller around and switching the -20 board back to A mode in order to get a better acceptance rate. Depending on the test bills, I saw a 20 to 40 % increase in acceptance.

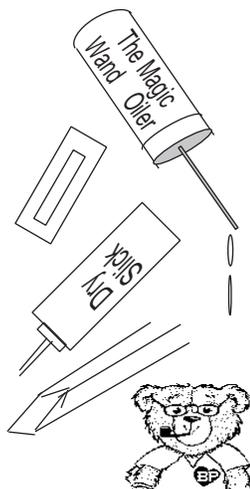
CLEANING ROWE HOPPERS !

Just brushing a Rowe hopper is not good enough to get rid of dirt build up on either side of the chain, A person should not scrap the plate with a sharp object like a screw-driver or use something like steel wool. Would you use these items to scrap a teflon coated pan ? Of course not ! You can make a wooden chisel out of hard wood or file/grind the back end of the hopper brush into a wooden chisel.

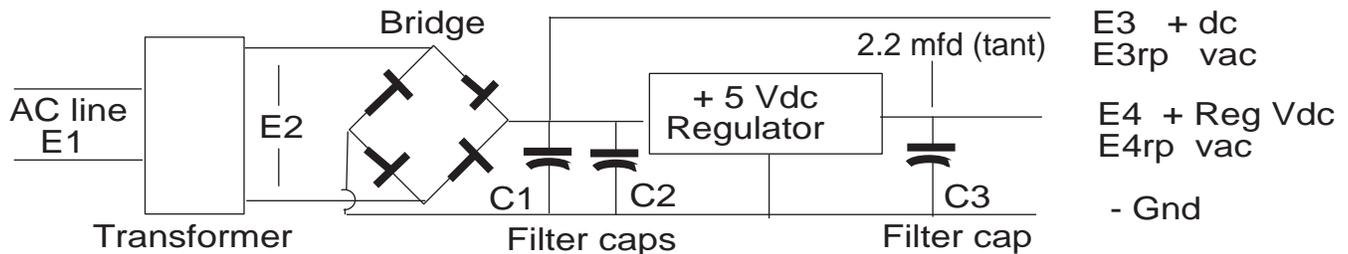
There are many problems which are due to a faulty power supply or low AC line voltage. One problem is a faulty filter cap (alla C1) where the DC voltage may be close to normal but the voltage has a large ripple value. As the ripple value increases what actually happens is the instantaneous voltage drops. These dips can create all kinds of system problems which you do not relate to power supply problems. A regulator may keep the average dc voltage close to the normal value but there are small (or large) dips in the output voltage.

| AC line voltage | E1 vac | 117 vac | |
| Transformer secondary | E2 vac | 11 vac | |

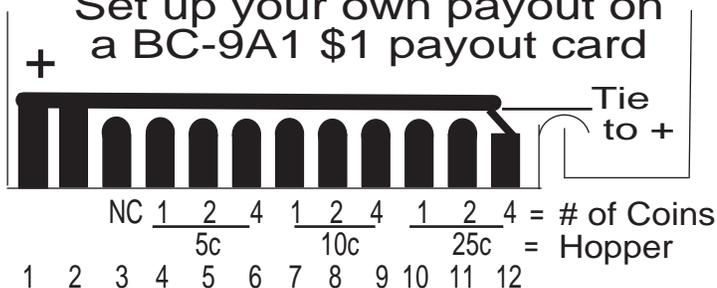
Set up your own payout on a BC-9A1 \$1 payout card

You can make your own BC9 payout card by connecting a count to the long + copper bar above the count connectors. I have tied # 12 to the + bar and this will give out 4 coins from the 25c hopper. With this layout you can make the card payout anything you need up to 7 coins per hopper.

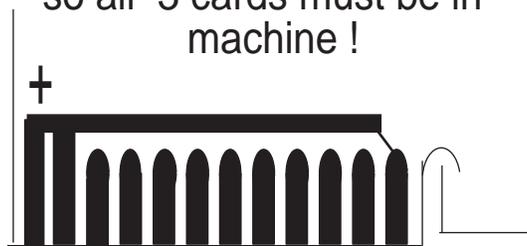
BC9A1

These cards are an interlock so all 3 cards must be in machine !

These two pins connected together are an interlock. Without all three interlocks in place the machine will not operate.

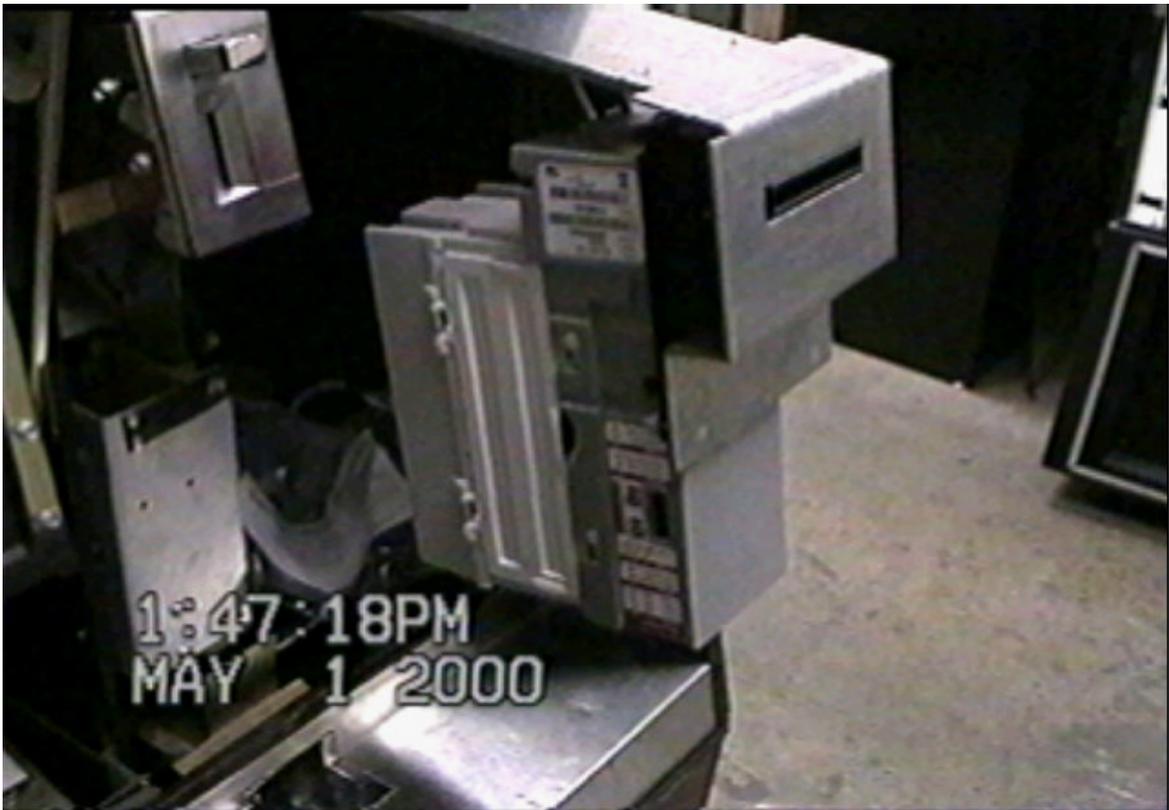
Capital Vending BC-11, 20, 25, 12, 35 Kits
by Bruno Puglia Feb 21, 2003

Basically here is what a Capitol Vending Kit looks like when installed in Rowe bill changers. Some kit users have not plugged in the coin mech connector or have cut the wires going to the lockout relay coil in the coin mech. You do have to disconnect the bill return switch as part of the installation. Some vendors did have trouble getting the system to work because they used switch settings for the Mars acceptor given in the instruction sheets. Actually you have to use the switch settings listed on the black box in the cable harness. **Use the VN2400 or VN2500 switch settings listing on the box in the cable harness.** Make sure you tie off the cable going to the acceptor otherwise when sliding the mounting back it may cut into the acceptor cable. Other than the problems listed users have had good results with these kits. Many users have let me refurbish their hoppers so they have extended the basic life of the changer several years. You can now get a \$1000 bill box.
